POL PIER REPAIRS  
LAJES FIELD , AZORES

FINAL FIELD INSPECTION REPORT  
FEBRUARY 1983

POL PIER REPAIRS  
LAJES FIELD, AZORES  
CONSTRUCTION INSPECTION VISIT NO. 4  
JUNE 4 TO JUNE 10, 1981  
CONTRACT NO. N-62477-79-C-0021  
MODIFICATION P-00003

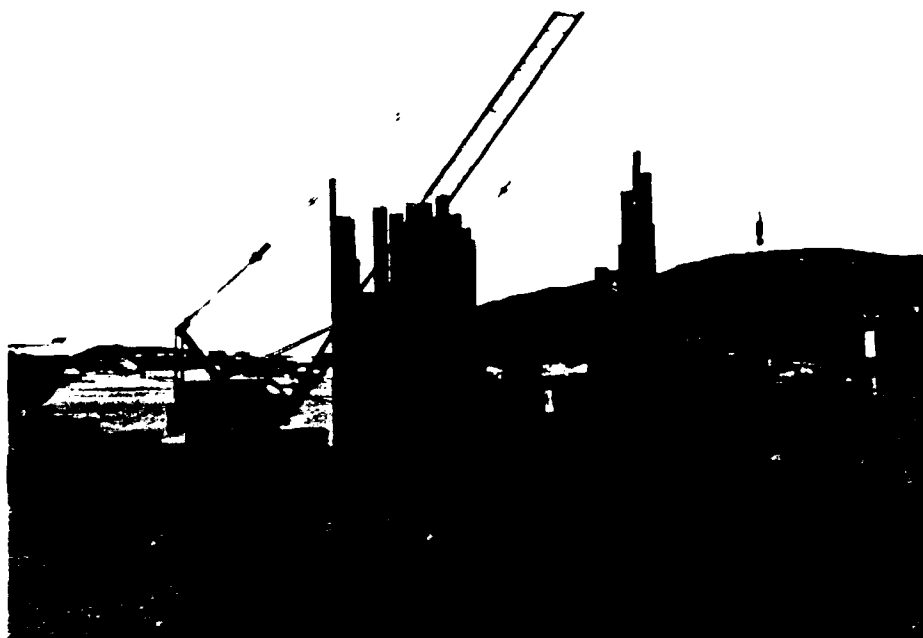
#### NEW SOUTH DOLPHIN

Overall View, Looking North. The North, East and South Walls Are Partially Driven. The South End of the East Wall Is "Hung Up" on an Obstruction About 5 Feet Below the Harbor Bottom.

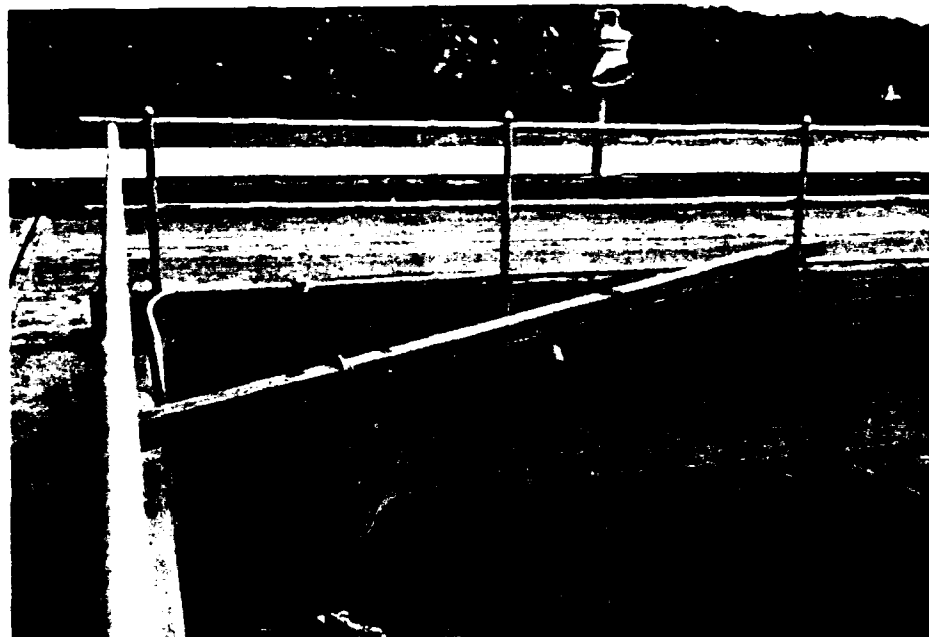
SPAN NO. 2 - APPROACH ROADWAY  
Longitudinal Crack in Facia Beam, About 60 Feet Long,  
to Be Chipped Out and Epoxy Patch Repaired.

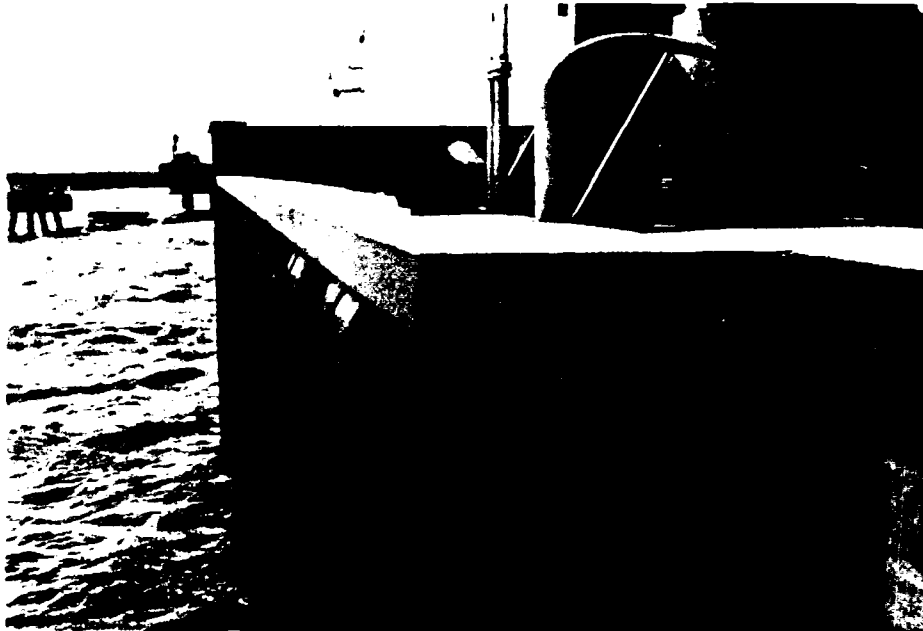
#### NEW SOUTH DOLPHIN

Looking south along the east face. Note that the top of the steel sheet piling was bent in, beneath the steel channel cap.
